Bowser Traction Mechanism Derailments: A Case Report

by Richard L. Allman, MD, MS

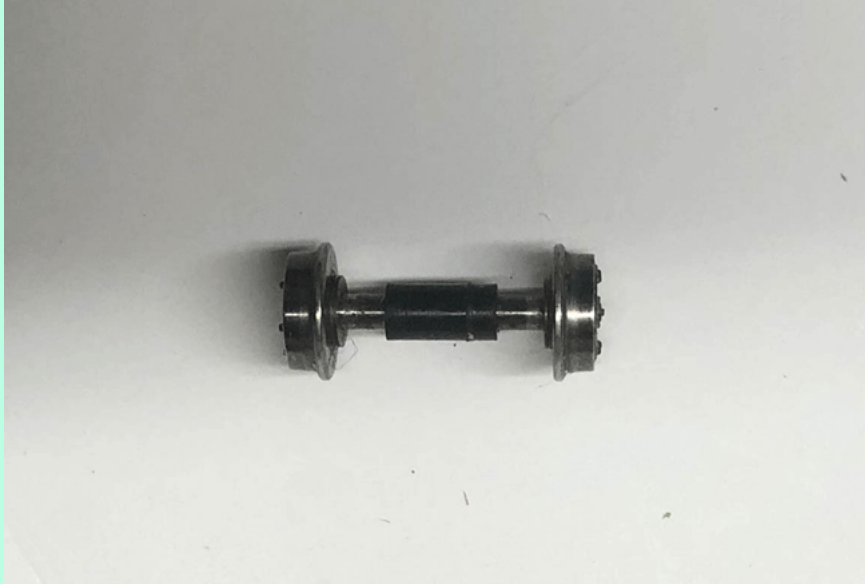
When the rear wheels and axle were removed, the first thing noticed was that one of the stub axles was no longer snugly held in the space sleeve, Bowser Part #1291, that holds both wheel and axle sets together. A close look under magnification revealed that there was radial split in the sleeve, which made the wheel loose and unstable in the sleeve and easily out of gauge. Why the wheels don't turn when the plate is in place is uncertain. It might relate to the bulge created where the sleeve is split. When the errant part #1291 was replaced, the problem was solved, and smooth operation was restored.

Figure 1. Bowser part #1291 between two wheel axle assemblies!

HO traction modelers have been using the Bowser traction drives since their introduction in 1999. Since that time, the drive has been a game changer. It is affordable, easy to install and if necessary, repair. For many of us, it is the default selection for powering models. Nonetheless, with time and operation, parts wear out. This is not due to any design flaw, but simple wear and tear. Those of us who use the Bowser drive, especially for any length of time, should maintain a stash of replacement parts, the most common of which are the sleeves for the stub axles. They are cheap, and the removal of the defective one and insertion of the stub axles into the sleeves takes less than 3 minutes, including the five second task of verifying the gauge. And if it is determined to be a cause for the problem, it cannot be ignored. And since the replacements are so cheap, attempting to repair a split one is a fool's

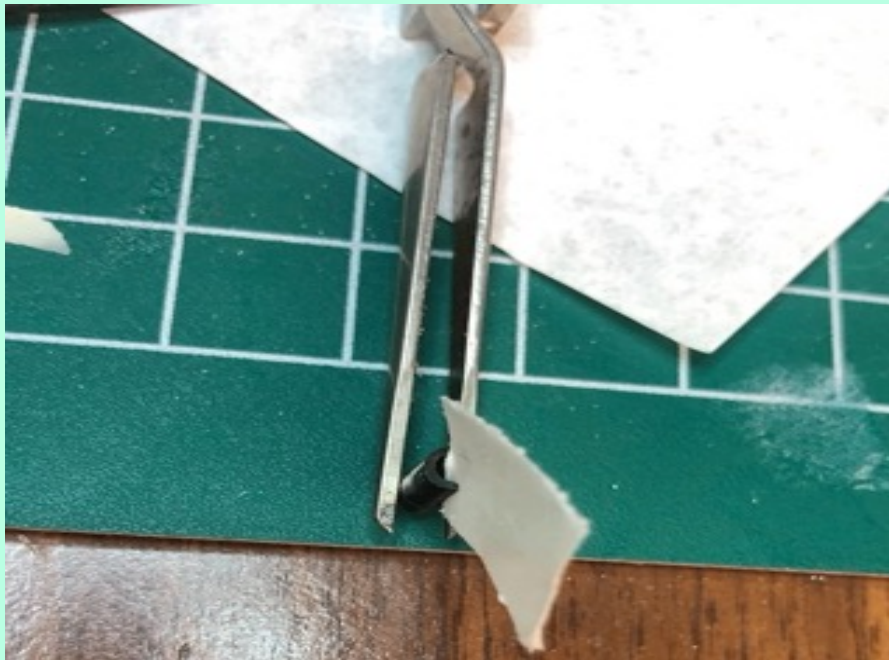
*Figure 2. A thin piece of styrene has been inserted in the radial break in the Bowser #1291.
Replacing the #1291 solved the problem!*

errand. Also recommended is keeping several of the sleeves with the gears for the drive truck, although so far, one of these has not suffered the same fate.
